Mitsubishi EGR Valve removal kit

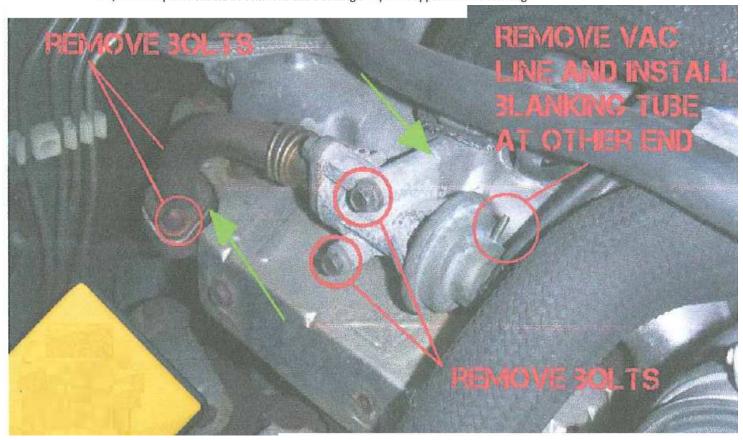
Firstly, ensure the vehicle is braked and in a safe working position. Locate the EGR valve and remove the four securing bolts shown on the picture marked in red, remove the rubber vacuum pipe from the valve but do not remove at the other end yet. The EGR valve and pipe should now pull away from the manifolds. It may need slight prising if it is stuck in place. After removal remove any loose dirt or corrosion trying not to allow any debris to fall inside the holes.

The EGR valve and extension pipe can be located on the left hand side of the engine (viewed from front) bolted between the exhaust manifold and the inlet manifold. Removal is simple and easily completed by anyone with basic mechanical knowledge. 4m40 and 4d56 engine versions may vary and have a different layout but the method of removal will be the same. If you are unsure feel free to email for further help or guidance. Fly by wire models may require the valve to be left in position. The valve is removed, blanked and then refitted so that the ECU still has the EGR module connected.

Place the blanking plates in their corresponding shaped positions and fix using the new bolts/nuts supplied. A sealing compound should be used but if the faces are clean, not necessary, tighten the bolts/nuts until secure but being careful not to over-tighten the bolts into the aluminium manifold and the threads can be stripped
